MYRTLE LAKE BIOASSESSMENT/INSPECTION November & December 2014; March 2015

On March 11th, 2015, Seminole County Lake Management Program staff Thomas Calhoun and Sophia Pengra surveyed Lake Myrtle's south pool.

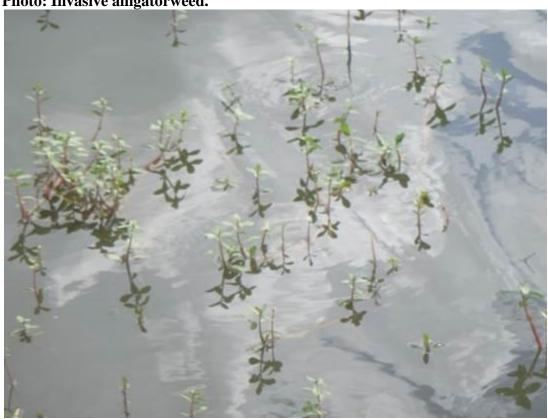
Invasive species present during the inspection included alligatorweed and torpedo grass, which was targeted during the treatment that took place March 31st. Dog fennel and broom grass was

Photo: Invasive alligatorweed.

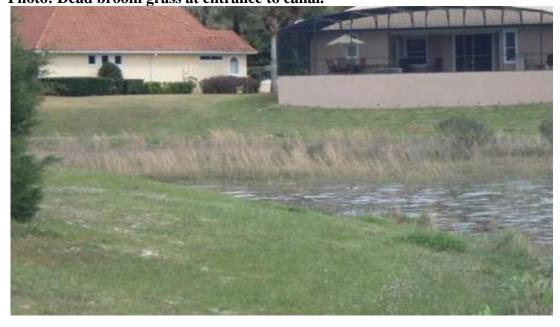
observed brown/dead from winter dieback. Native species present included: canna, yellow cow lily, maidencane, pickerelweed, duck potato, fire flag and cord grass.

Photo: Dead broom grass at entrance to canal.

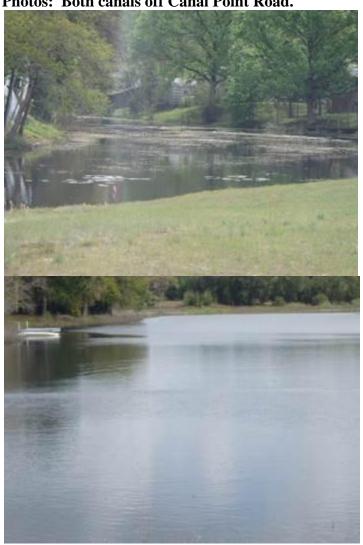
The Crowder canal off Canal Point Road area was also inspected. The canal vegetation was found in good shape and was observed to be high in water elevation. Invasives present included: alligatorweed, torpedo grass, primrose willow, and other terrestrial weeds growing along bank. It is recommended to mow and weed-whack to the water's edge and treat the alligatorweed, primrose willow, and torpedo grass. Replanting with natives after successful treatment is highly recommended.

Photos: Both canals off Canal Point Road.

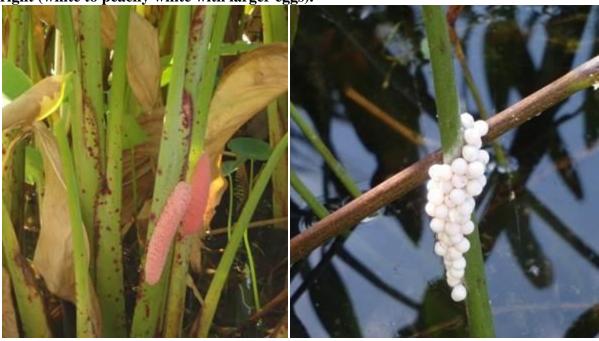
The invasive apple snail continues to be observed in the south pool of Myrtle Lake canal. Due to their high rate of reproduction, they have the potential to negatively impact the ecosystem of the lakes and canal. They have been known to decimate aquatic plant populations in other areas. The best method of control is hand removal of the large adult snails and scraping and crushing the egg clutches (clusters). Please only remove the bright pink egg clutches. More information can be found on the FWC website here http://myfwc.com/media/673720/FWC applesnails FLMS handout.pdf.

Photo: Exotic snail eggs on left (bright pink with small eggs), native apple eggs snail on

right (white to peachy white with larger eggs).

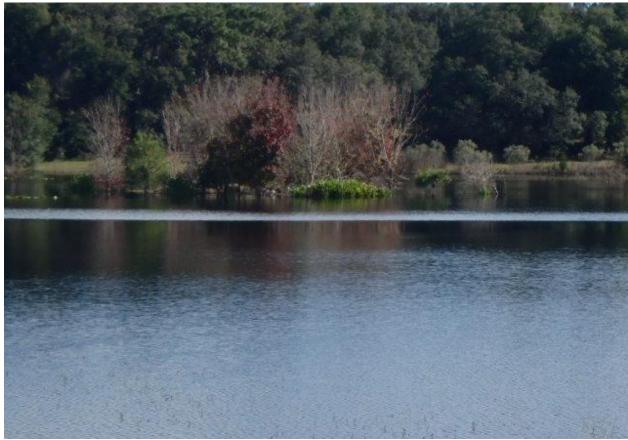
Native species present included: canna, yellow cow lily, maidencane, pickerelweed, duck potato, fire flag and cord grass. The native vegetation was found to be in good condition and expanding along the shores of the wildlife spoil islands. No submersed aquatic vegetation (SAV) was observed. There was no herbicide treatment in December. Invasive apple snail was present during this inspection.

Photo: Wildlife island.

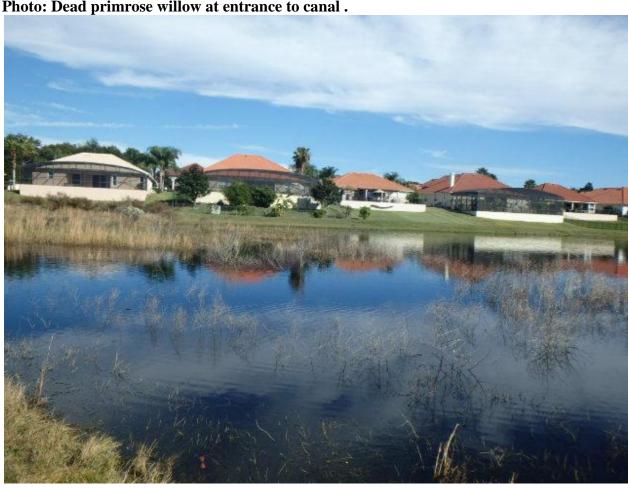
Invasive species present during the inspection included alligator weed and primrose willow (dead). Previously treated/dead primrose willow can still be seen from the September herbicide application; overtime it will sink and decompose. There are fewer primrose willow stems observed standing than in previous inspections.

Photo: Dead primrose willow at entrance to canal.

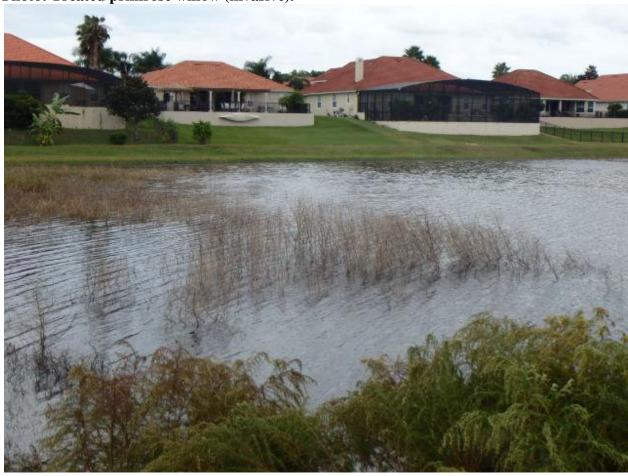
Photo: Treated primrose willow (invasive).

Invasive species present during the inspection included: alligatorweed, torpedo grass, primrose willow, dog fennel, and Carolina willow. Some dead primrose willow can still be seen from the September herbicide treatment, but will soon fall down into the water and decompose. Native species present included: canna, yellow cow lily, pennywort, maidencane, pickerel weed, duck potato, fire flag and cord grass. The native vegetation was found in good condition and expanding along the shores of the wild life spoil islands.

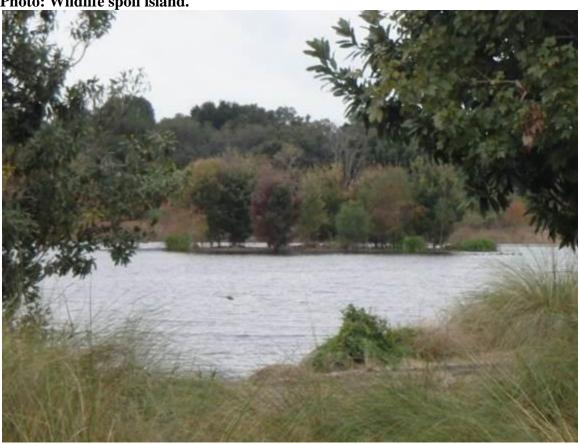
Photo: Wildlife spoil island.

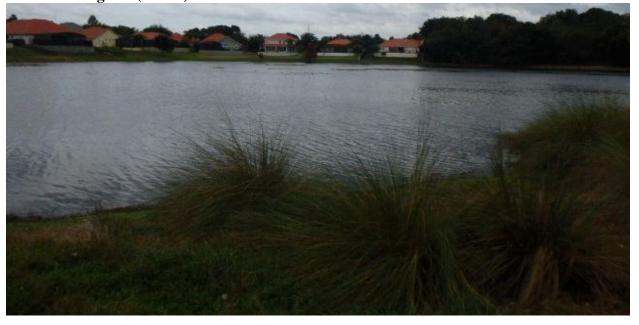
Photo: Cord grass (native).
